Rock Mass Classification on Opak Fault Impacted Zone in Mengger Hill, Bantul, Yogyakarta

Abstract

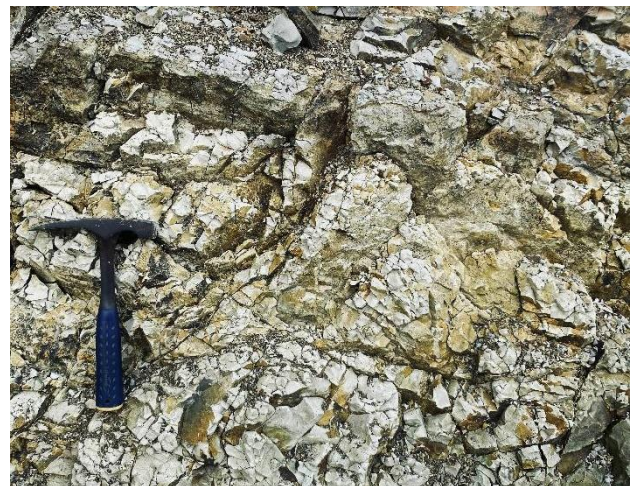
The observation point showed that the outcrop is consisted of pyroclastic rock types as shown in Fig. 2. It has a white-grey colour in fresh condition and a bit brownie colour when it gets weathered. The structure are a massive type bedding plane that have more than 1 meter long of each rock layers. The grain size ranges from 0.04 mm to more than 0.006 mm that classified as fine ash (< 2 mm). The mineral composition of the rock consists of SiO₂ or silica (predominantly glass). Based on the observation, the rocks in this location are classified as tuff (Schmidt, 1981).

Fig. 2. Rock Mass Outcrop in Mengger Hill.

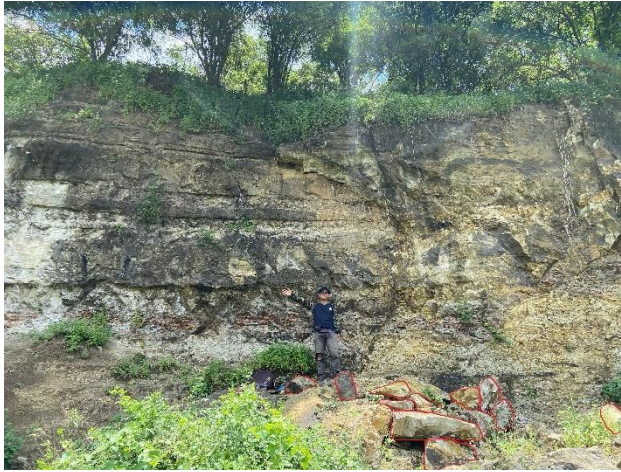
On the western slope, there are indications of recent landslides in the form of large blocks. This can be seen in Fig. 3 (indicated by red marks), which shows the remains of landslides at the foot of the slope where the data was collected.

Fig. 3. Large Blocks Failures Next to The Western Slope.

SMR calculation rating classified as good quality rock mass with the Ila sub-class that ranges from 71 – 80. It indicates that the rock mass stability is stable with a potential failure of block failures. These results match and correspond to the field conditions previously seen in Fig. 3 regarding the presence of large rock blocks at the base of the slope when the observation was conducted. This good class have an empirical probability of failure 0.2 or 20 % which means the rock mass still has the potential to collapse and needs to be monitored regularly. Spot bolting needs to be installed on several rock blocks that are considered to be at risk of collapse.

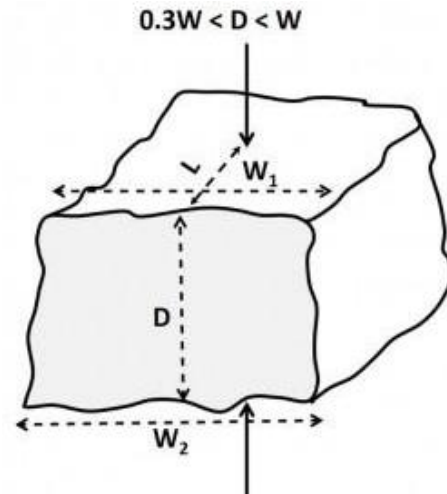
The last type of point load test is the irregular lump test that will be explained more detail below. Since the rock samples from Bukit Mengger are irregular in shape, this test will be carried out in accordance with the irregular lump test standard based on ISRM (1981). The dimensional requirements for this test are as shown in Fig. 4 where W represents the average width of W_1 and W_2 , D is the distance between the cones that have to be greater than 0.3 W and less than W itself.

Fig. 4. Dimensional Requirement for Irregular Lump Test.

W can be measured by using Eqn. 1.

Then, the distance between cones have to be converted into Equivalent Core Diameter (D_e) using Eqn. 2 where D_e are the inverted equation of circular area.

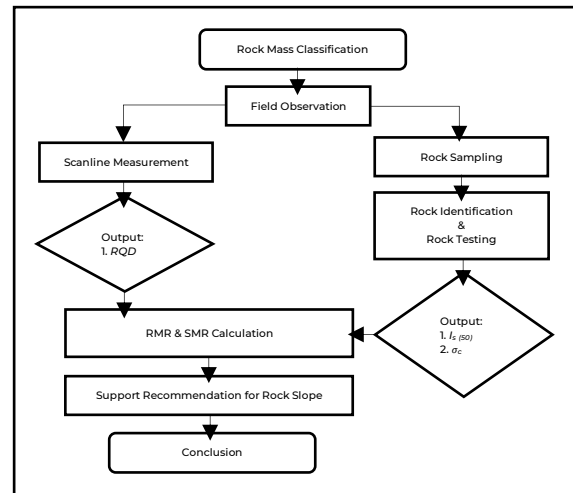
Fig. 5. Workflow of Research.

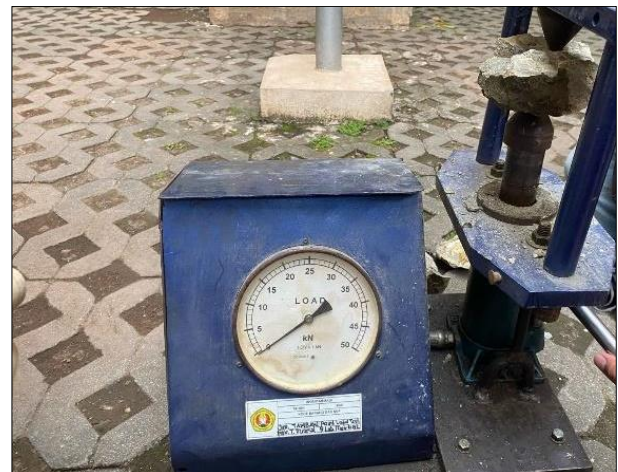
The point load test was done for 5 irregular lump tuff samples. The dimensional requirements was prepared and checked before the rock had to be tested to validate that the D have to be less than W and greater than $0.3 W$. The tests was conducted at Rock Mechanics Laboratory of UPN "Veteran" Yogyakarta as shown in Fig. 6. Result of the point load tests can be seen in Table 2.

Fig. 6. Point Load Test at Rock Mechanics Laboratory.

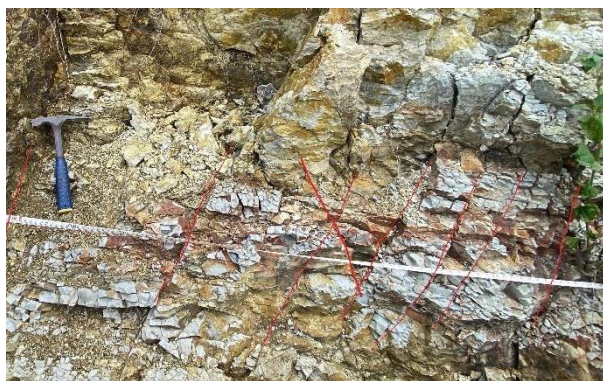
In measuring the orientation and spacing of discontinuities using the scanline method, the results showed orientations of 7 joints over a scanline length of 2 meter. The scanline length was considered to be 10 times the estimated spacing. The spacing was early estimated about 10 to 20 cm per joint. Result for the the dip and dip direction measurement from geological compass can be seen in Table 3 following with the true spacing result from scanline which are also shown in Table 4. It shows 2 classification of spacing ranges for RMR rating. Same as the rating for the first parameter, the smallest rating will be chosen for the pesimistic scenario (8 rating).

Fig. 7. Scanline Measurement

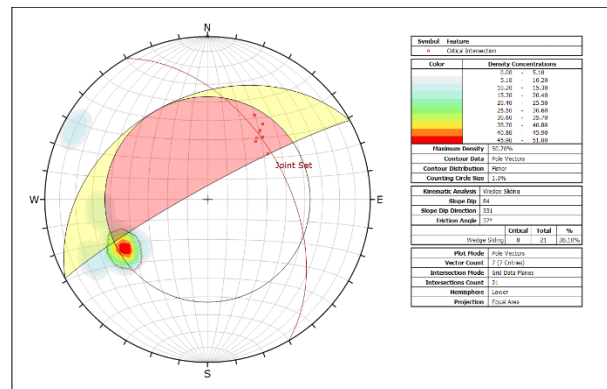
64 value means that the rock mass quality on Mengger Hill is classified as Good Rock (Class No. II) with an empirical rock mass friction angle of 37° and empirical rock mass cohesion of 320 kPa. Before doing the SMR calculation, the kinematic analysis need to be done first in order to know about the failure potentials. Kinematic analysis show the orientation set has one joint set that has dip value of 54° and dip direction N 064° E where the slope dip are 84° and slope dip direction are N 331° E. The failure potential has the biggest percentage at Wedge Failure as shown in Fig. 8 where the percentage are 38.10 %.

Fig. 8. Kinematic Analysis

Based on this basis, SMR calculations will be performed for potential wedge failure, where calculations for each F factor can be seen in Table 5.
